Presentation on 16th June 2016

The presentation on the 16th June was given by John Alexander and Josh Paget from Alexander Design. Alexander Design is the appointed architectural practice for the design and rebuild of St Peter's. The following is an interpretation of the presentation as it isn't possible to detail the whole presentation in text here.

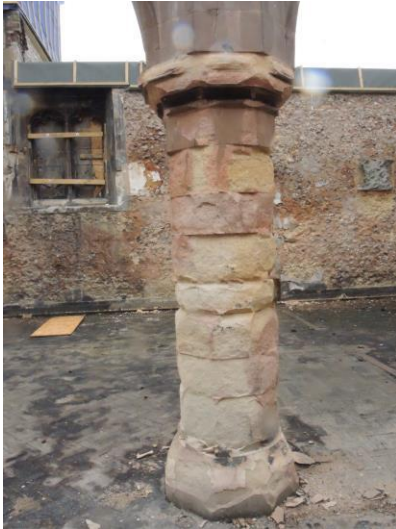
An arcade pillar

1. West and South walls : flint heat fractured
2. Vestry : no foundation, requires attention
3. North Arcade / Nave : stone heat fractured and spalled beyond repair
4. Chancel Arch : stone heat fractured and spalled
5. Traceries : some sound, but there is spalling and historic cracking to ironwork and heat spalling
6. North wall : sound

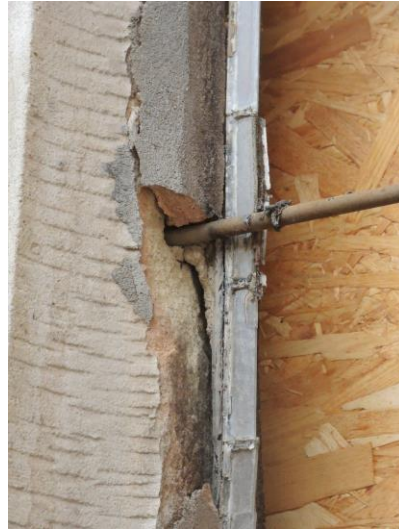
A window

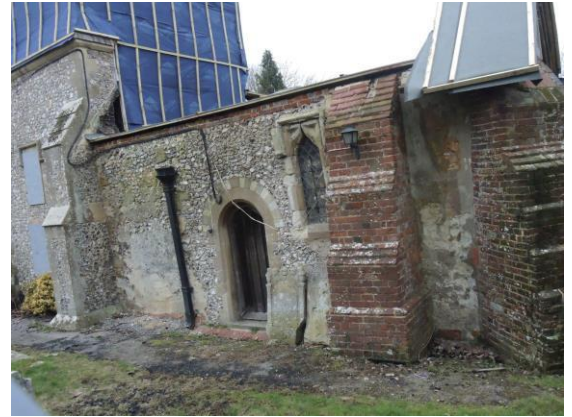
The south east corner

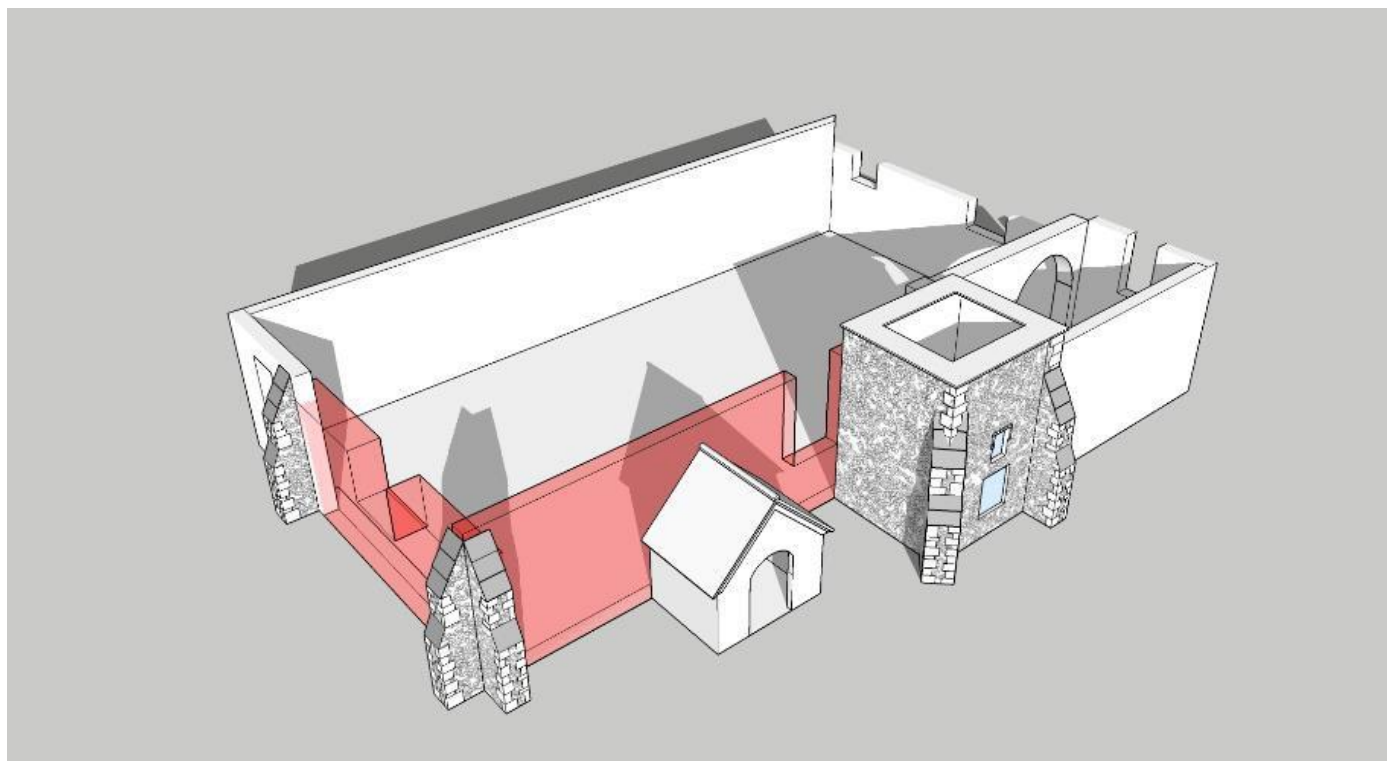
Retained viable walls (pink shows repaired / replaced)
