Intrusive Investigations

Images of Intrusive Investigations

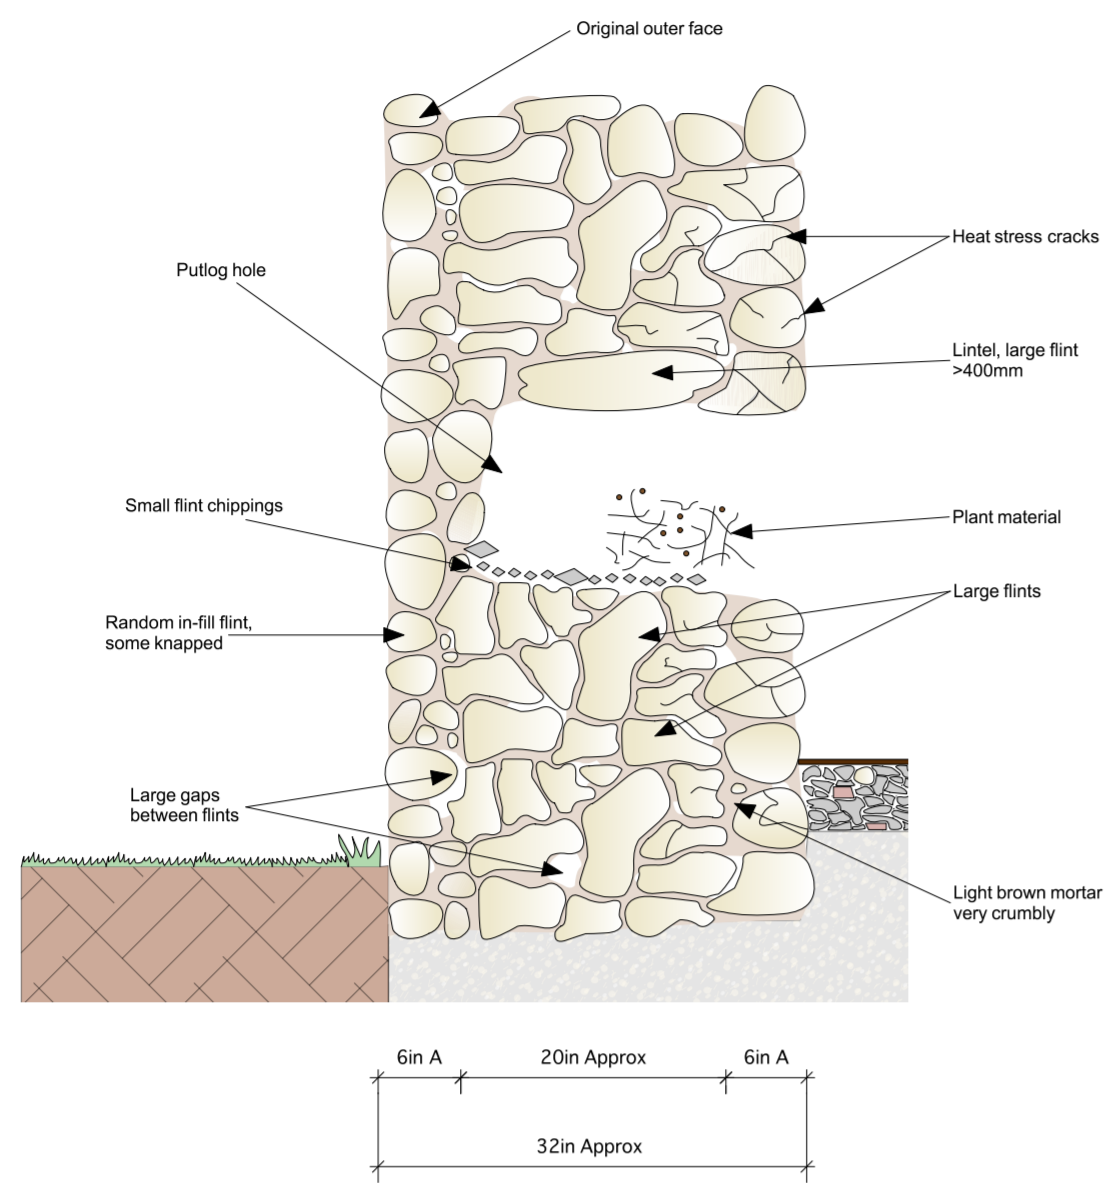
Section AA

- General Notes
- Random arrangement of flints, all different sizes
 - Some loose, some rigid
 - The mortar is mainly light brown, very crumply and flaky
 - Some flints are cracked and fall apart very easily
 - Large gaps between some of the flints
 - Small flint chippings in the trial hole, primarily flaking off the flints above

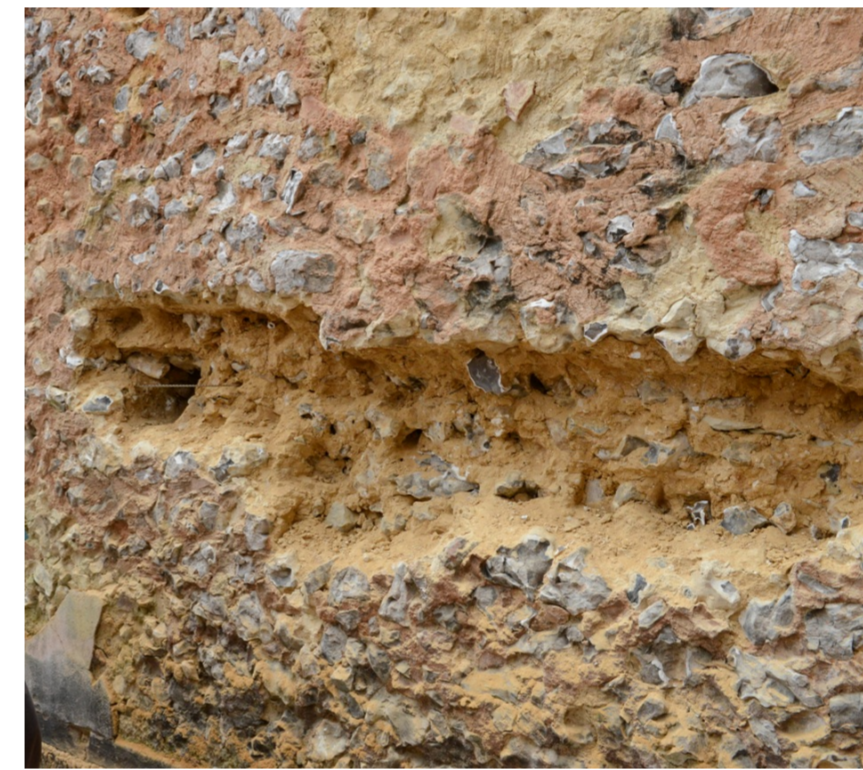
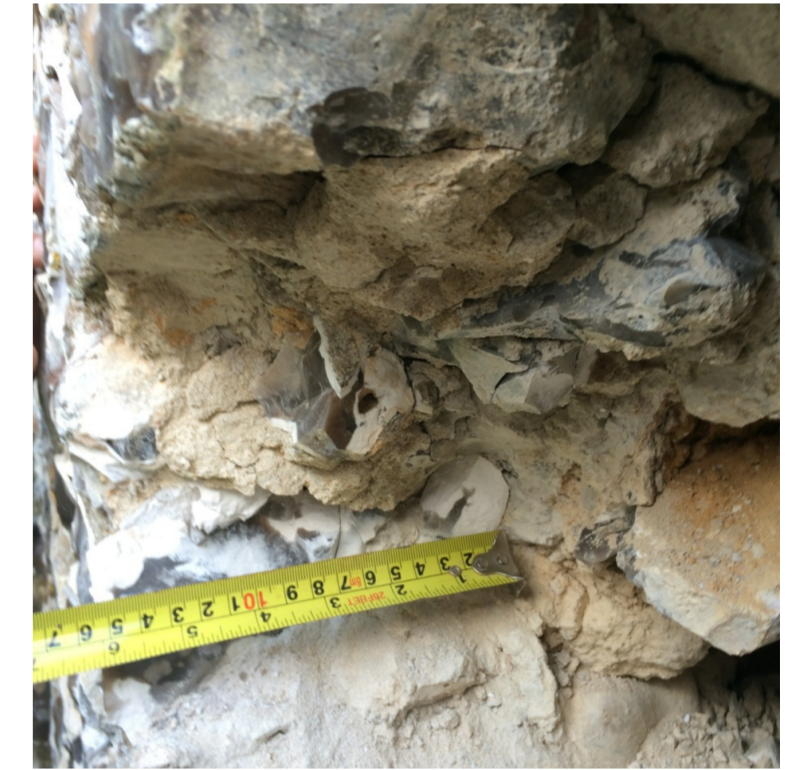
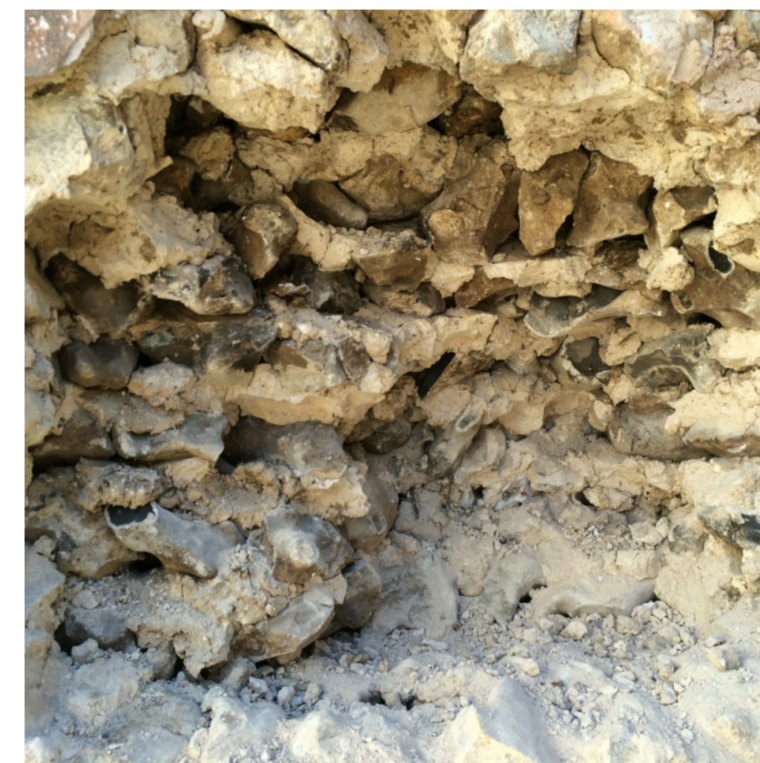
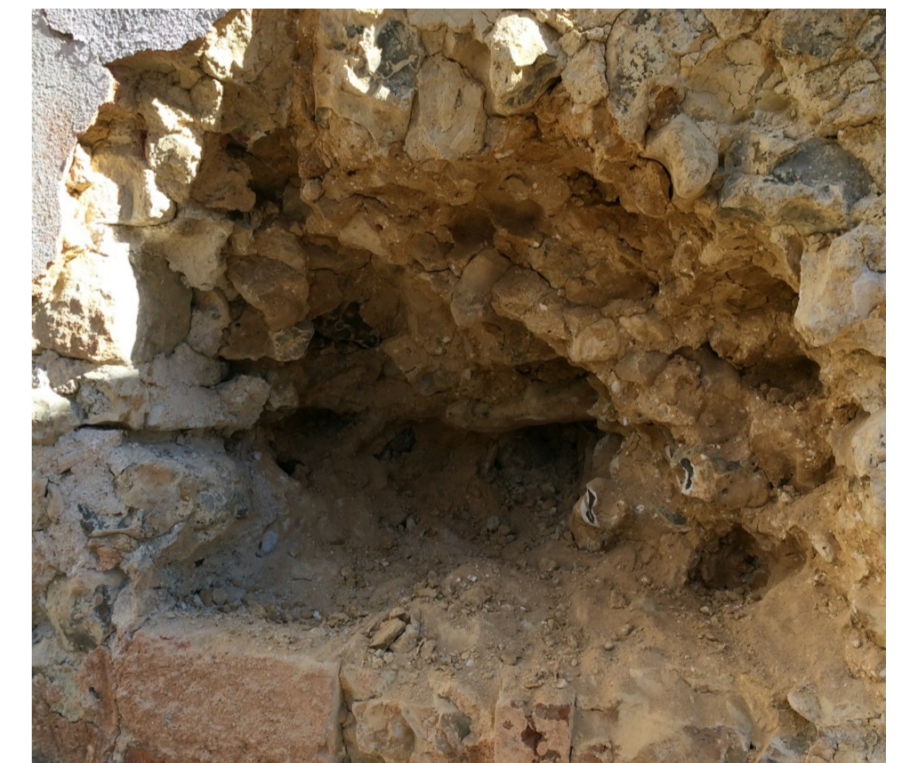
- General Notes
- Random arrangement of flints, all different sizes
 - The mortar is mainly light brown, very crumply and flaky
 - Some flints are cracked and fall apart very easily
 - Large gaps between some of the flints
 - Small flint chippings in the trial hole, primarily flaking off the flints above

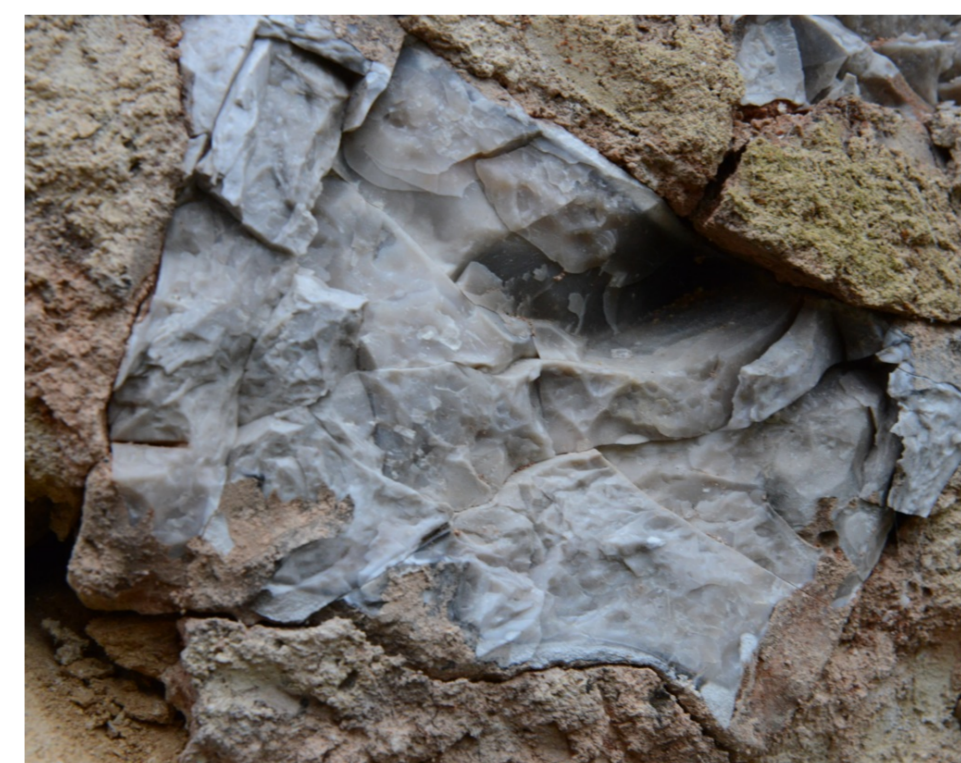
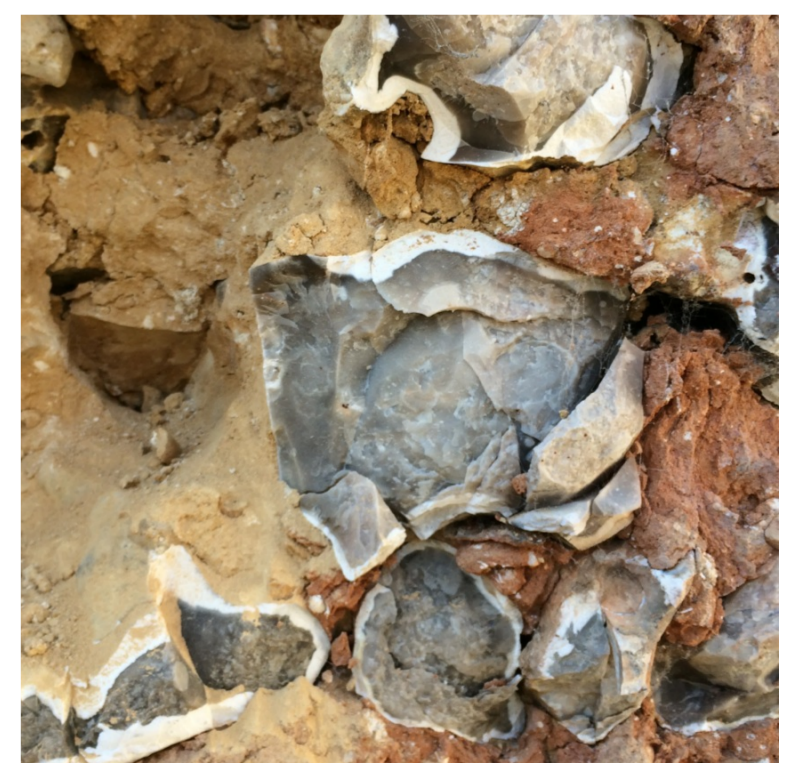
Section CC

- General Notes
- Random arrangement of flints, all different sizes
 - The mortar is mainly light brown, very crumply and flaky
 - Some flints are cracked and fall apart very easily
 - Small flint chippings in the trial hole, primarily flaking off the flints above
 - Outer skin of knapped flint added at a later date
 - Victorian foundation under over skinned area of the wall, unknown what the older part of the wall is built on
